Refurbishment Works to original Victorian vaulted ceiling, corroded beams and pillars.

Smith and Brenson Case Study

Bristol South Swimming Baths

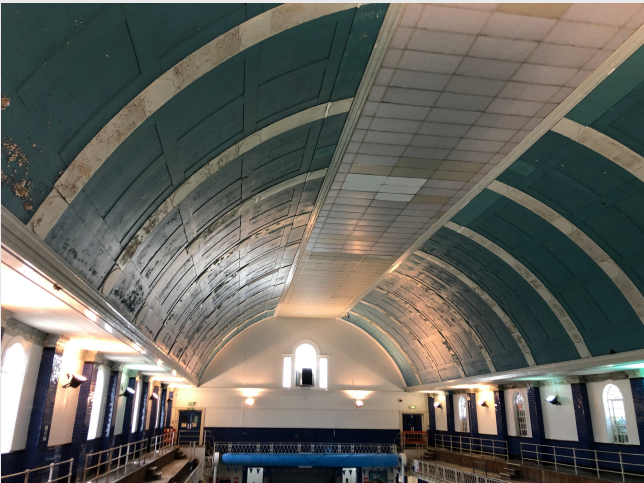
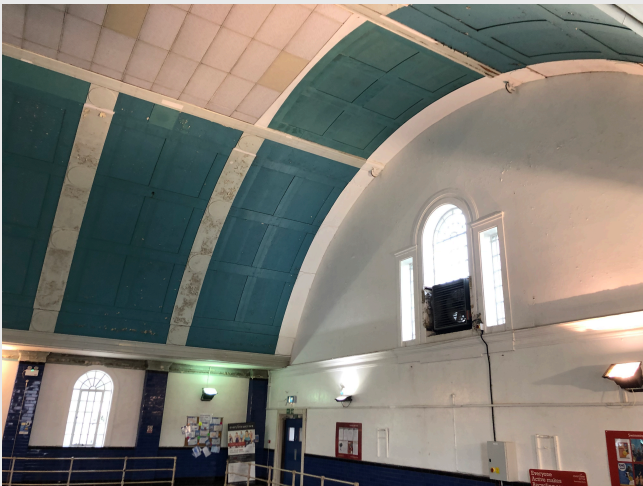
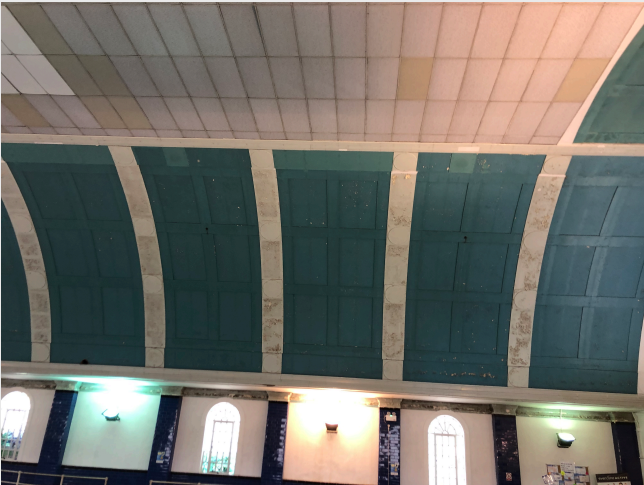
Before Photos

Due to extensive leaks in the fabric of the roof at the South Bristol Swimming baths, the original Victorian vaulted ceiling below had sustained extensive damage. Some of the original panels had come loose and debris had even fallen into the pool below.
